Village of Roslyn Historic District Board GUIDELINES FOR ROOFING

These *Guidelines* were prepared to assist property owners with information when considering the repair, alteration or installation of roofing. They are not intended to replace consultation with qualified architects, contractors and the Historic District Board (HDB). The HDB will be happy to provide a preliminary consultation addressing design or materials issues to potential applicants free of charge.

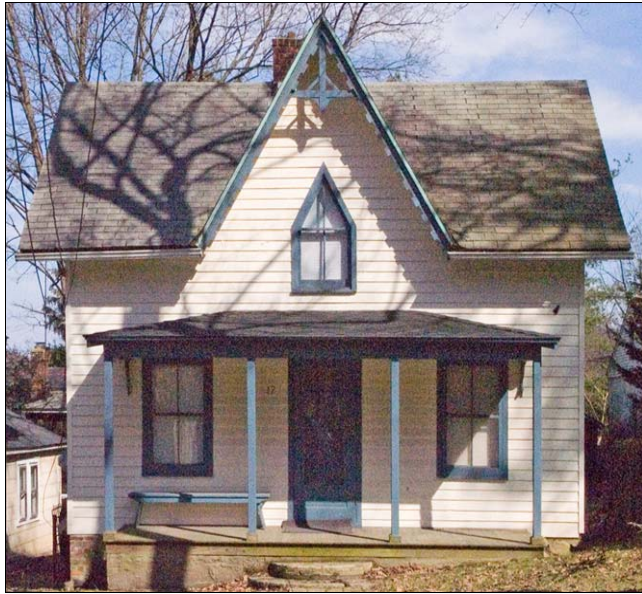
Roof forms, such as this side gable roof with an intersecting front gable, are an important feature in defining a building's style. In this case, the roof forms and detailing of the barge board and gable end, help to identify it as a Gothic Revival cottage. The porch has a shallow half-hipped roof.

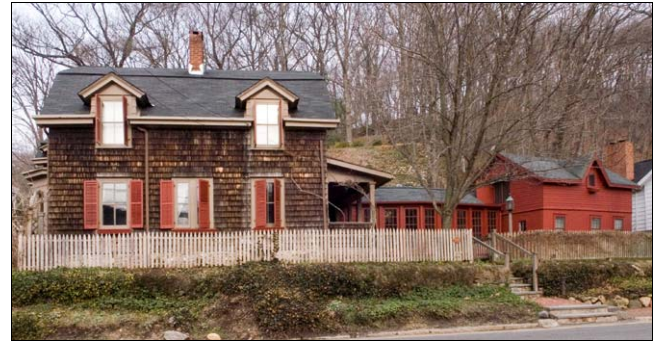
The gambrel roof is a distinguishing stylistic element of this Dutch Colonial Revival house. Various roof shapes are used at the later additions including a shed roof porch, a side gable roof addition with an intersecting gable at the front elevation at the secondary block.

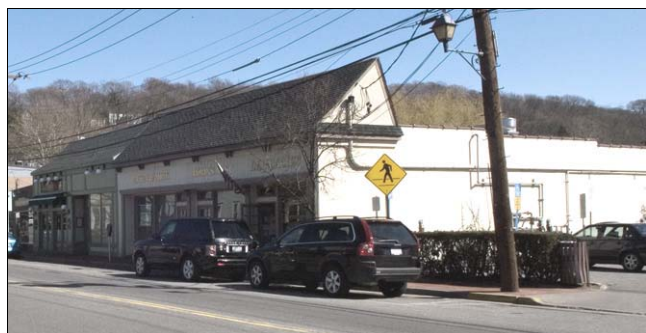
This commercial building has a “decorative” side gable roof at the front elevation, but the majority of the building has a flat roof.

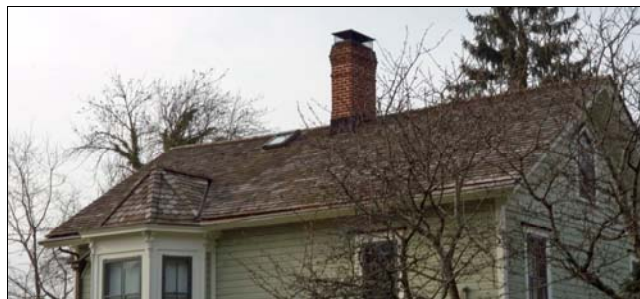
Wood shingles are a locally traditional roofing material.

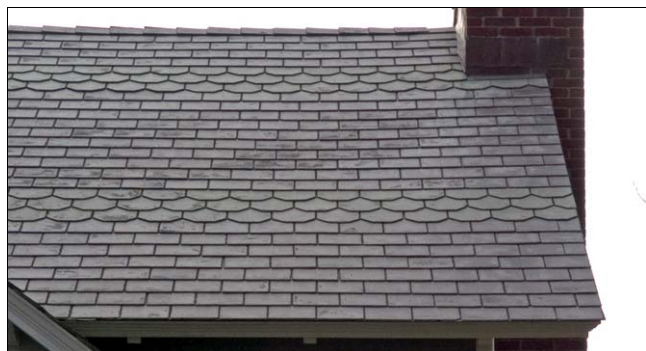
Slates are available in a variety of shapes and colors. The most common color in the Village of Roslyn is grey.

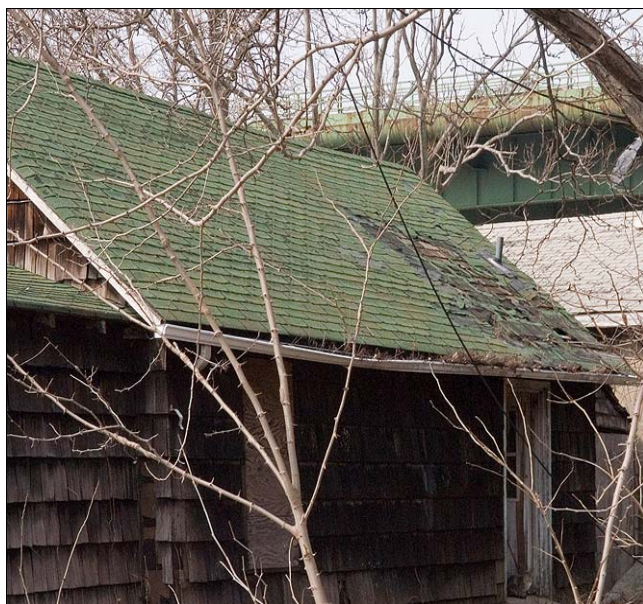
Mineral granules on the asphalt shingles have almost completely worn away. Large areas of shingles are dislodged and can be found in the gutters and on the ground. The gutters are filled with leaves and debris.

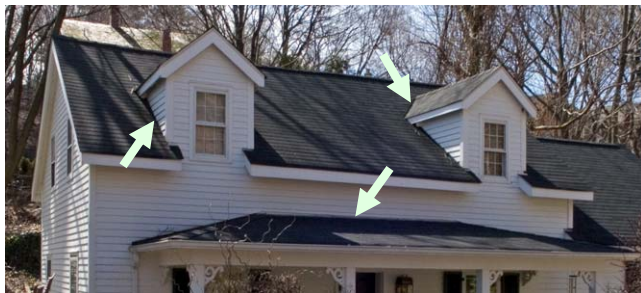
The arrows indicate areas where flashing is typically located.

Flashing is made of thin sheet metal formed to prevent water from entering a building at joints, intersections and changes of pitch. It is typically installed around chimneys, parapet walls, dormer windows, roof valleys, vents, and intersections of porches, additions or bay windows.

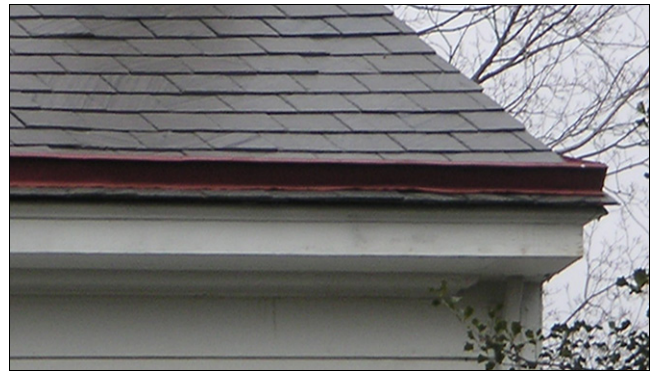
Pole gutters, also known as parallel gutters or “Yankee” gutters, are built-in gutters located near the roof edge to capture rain water and direct it towards a downspout. They are typically formed of wood, placed vertically to the slope of the roof and wrapped in metal flashing.

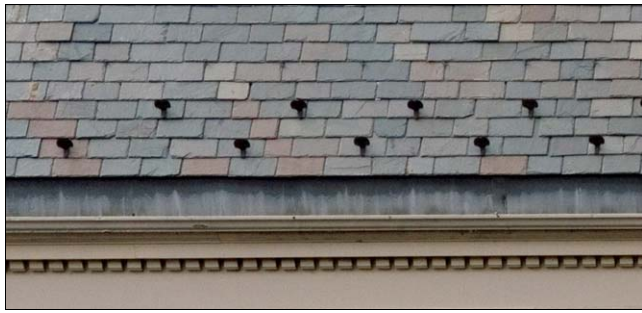
Snow birds, known as snow guards, are typically cast metal or bent wire devices arranged in a staggered pattern near an eave to prevent large masses of snow from sliding off a roof. They can also protect eaves, cornice and gutters, and take advantage of the insulating effect of snow.

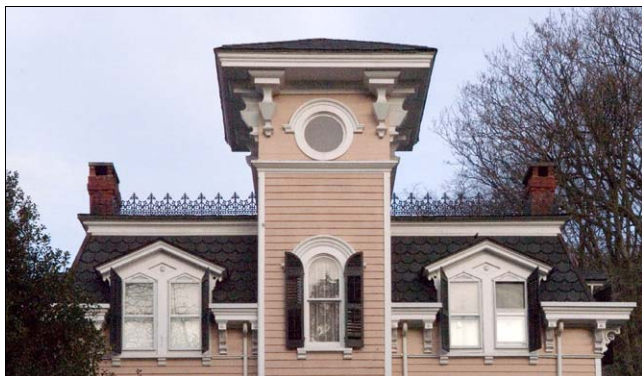
This roof has a variety of features including the central tower, bracketed overhanging eaves, cresting along the top of the Mansard roof edge, scalloped shingles, and a pair of brick chimneys.

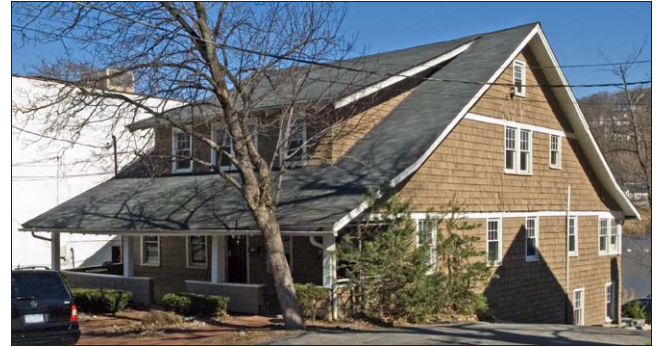
This shed roof dormer, with paired and single windows, adds additional space to the second floor of this house.

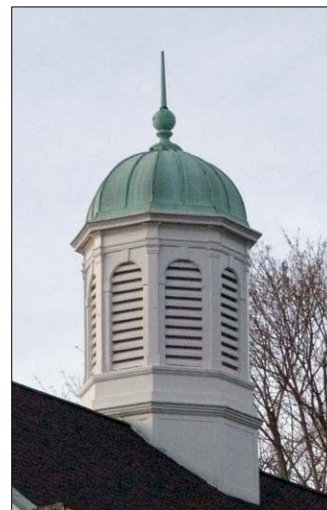
Cupolas, also known as monitors or belvederes, are structures that project up from the roof, used for ventilation with louvers, or as lookouts with windows. They are often found on agricultural outbuildings to provide ventilation for the animals housed below.

This cupola features a standing seam copper roof and is topped by a finial.

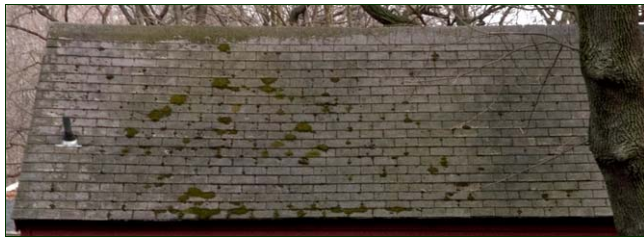
Moss growing on roofs is an indication of moisture. Shingle surfaces are worn and roof replacement may be warranted.

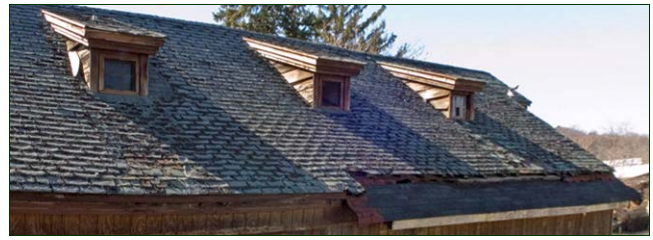
Several of the asphalt shingles are completely worn and areas of the underlying roofing have been exposed.
